IN THE UNITED STATES DISTRICT COURT FOR THE NORTHERN DISTRICT OF GEORGIA ATLANTA DIVISION

DECLARATION OF HARRI HURSTI

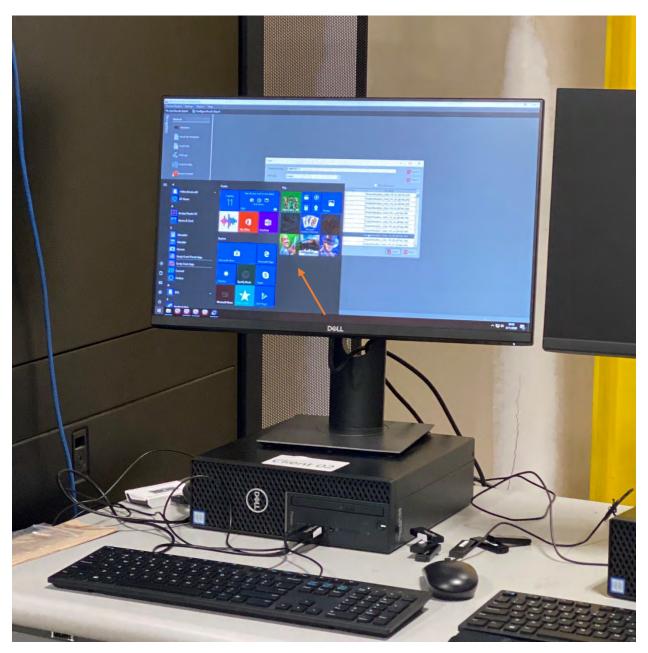
EXHIBIT C:

- 34. Since Georgia's Dominion system is new, it is a reasonable assumption that all machines in the Fulton County election network had the same version of Windows installed. However, not only the two computers displayed different entertainment software icons, but additionally one of the machines in Fulton's group of election servers had an icon of computer game called "Homescapes" which is made by Playrix Holding Ltd., founded by Dmitry and Igor Bukham in Vologda, Russia. Attached as Exhibit C is a true and correct copy of a photograph that I took of the Fulton voting system computer" Client 02". The icon for Homescapes is shown by the arrow on Exhibit C.

one of the first and most basic steps in the hardening process. In my professional opinion, independent inquiry should be promptly made of all 159 counties to determine if the Dominion systems statewide share this major deficiency.

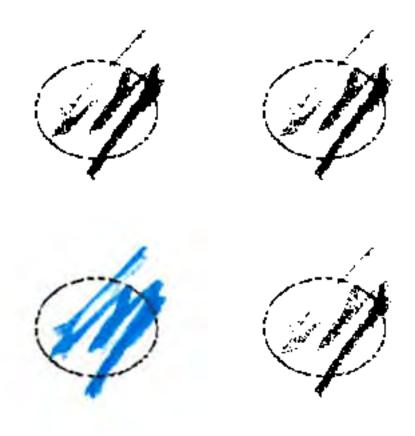
EXHIBIT H:

- 62. Dominion manual for ICC operations clearly show that the scanner settings are changed from neutral factory default settings. EXHIBIT H shows how these settings applied different ways alter how a blue marking is converted into Black-and-White only image.

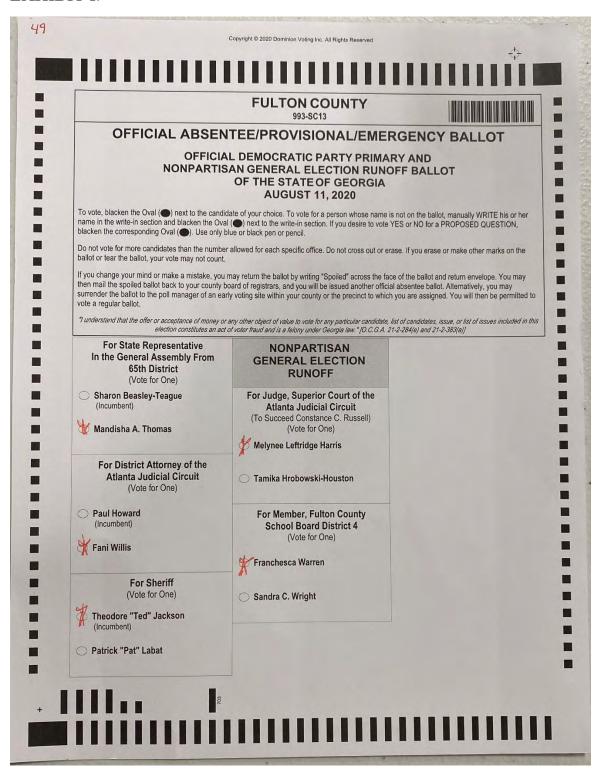
EXHIBIT I:

- 64. On the August 17th at Fulton County Election Preparation Center Professor Richard DeMillo and I participated in a scan test of August 11 test ballots using a Fulton County owned Dominion precinct scanner. Two different ballot styles were tested, one with 4 races and one with 5 races. Attached as Exhibits I and J show a sample ballots with test marks.
